# Jubilee River, Black Potts weir repairs update

May 2021

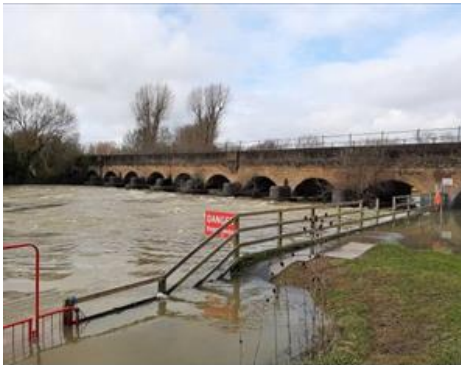
Feb 21: Unable to work on site due to high river levels

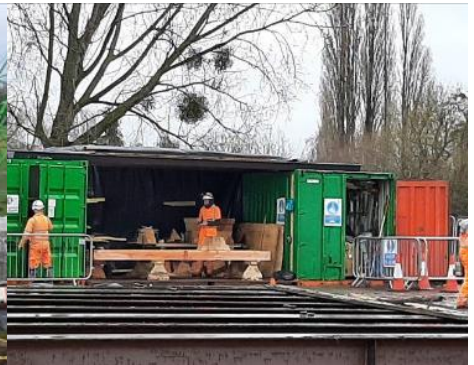
Feb 21: Preparing stop logs whilst we were unable to work in the water during high flows

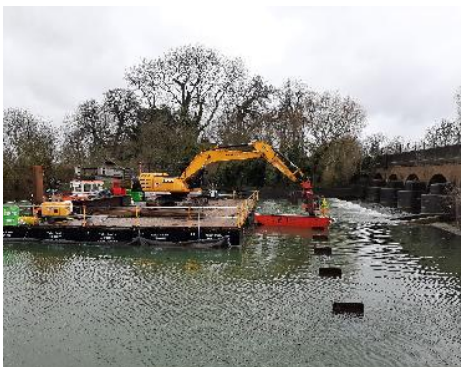
Feb 21: Installing piles for stop logs to slot into

- We have built a cofferdam incorporating stop logs on both upstream and downstream sides of the weir. The cofferdam allows us to de-water and dam the work area so that we can construct the new reinforced apron. If flood conditions are forecast the cofferdam would be removed to enable us to use the Jubilee River.

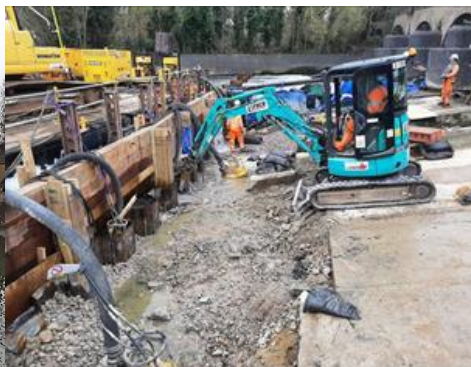
Feb 21: Excavating the weir apron. The apron provides protection from the effects of fast flowing water

- We have continued to refine the detailed design for the repair works following updated hydraulic modelling and assessment of the riverbed
- In the first phase of the repair works between October and December 2020 we cut and removed the downstream end of the old weir apron (the area that protects the weir and river bed from erosion) and placed new sheet piling.

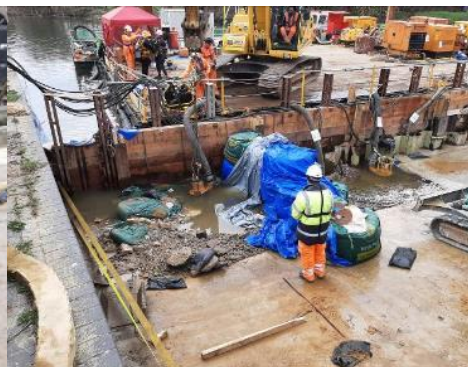
March 21: Pumping out the working area. Note wooden stop logs inserted between piles to create a cofferdam

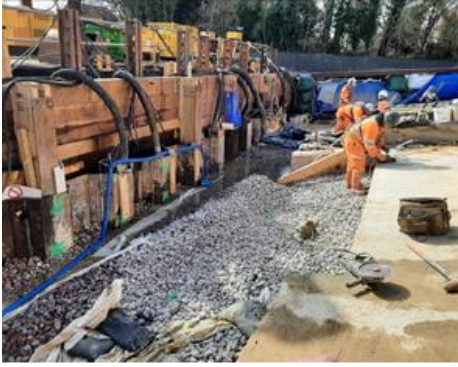
March 2021: Drainage base layer being installed

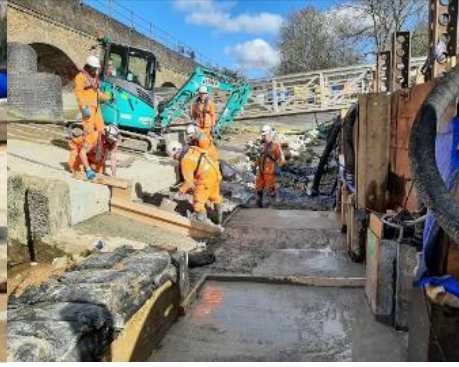
March 2021: Placing blinding layer. This is a base layer of concrete

- We have cast a blinding, or base layer, of concrete and installed steel reinforcing mesh cages that have been tied into the existing apron
- We then cast high strength concrete to form the new completed weir apron slab. Each section is made watertight with mastic sealant between the slabs.

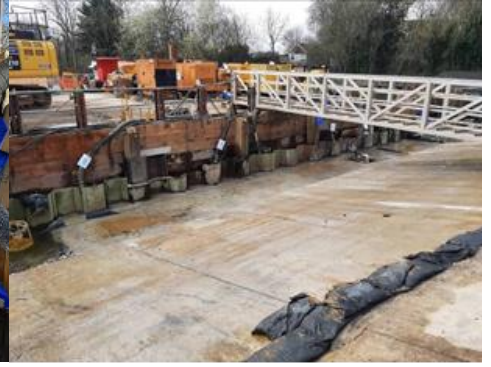
March 2021: Completed blinding

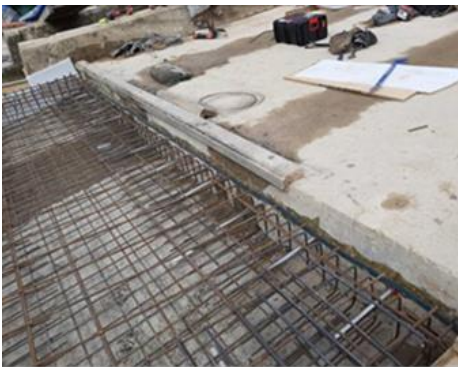
March 2021: Section of base showing the steel wire reinforcement.

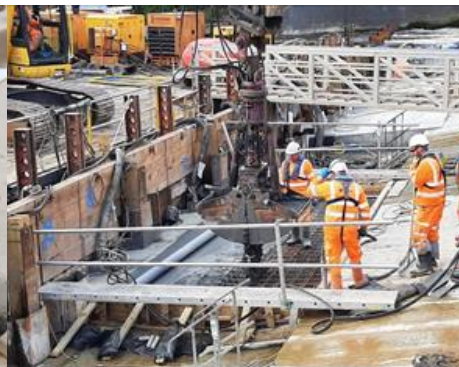
April 2021: Casting high density concrete

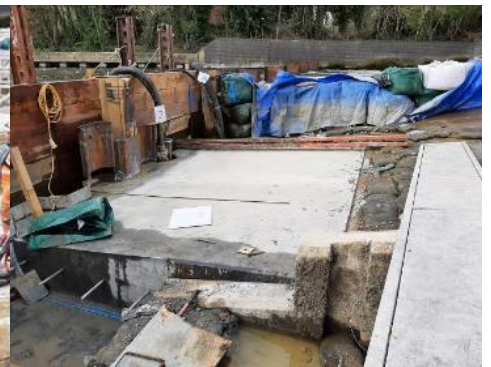
April 2021: Completed section of weir apron

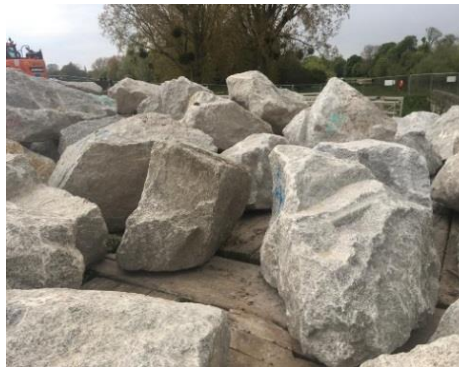
Rock armour waiting to be placed following completion of weir apron

- Once the apron is complete we will begin laying rock armour.
- Prior to installing the rock armour we will excavate the river bed to make room for 2 layers of rock and to provide a connection into the existing bed.
- The rock armour consists of large boulders that naturally interlock together. This controls erosion from fast moving water over the weir by dissipating the waters energy.
- During this phase of works, we can continue to operate the Jubilee River if flood conditions are forecast
